Good Grease, Good Landing

Machine Design Article, November 3, 2005

Tests reveal that a new lithium-soap-thickened, synthetic grease may help mission-critical aerospace components keep rolling under extreme loads and corrosive environments.

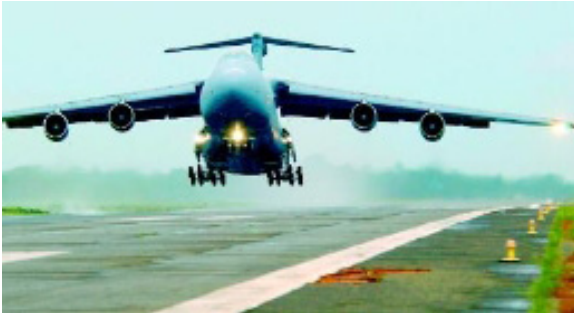
The C-5 galaxy military transport when fully loaded weighs up to 380 tons.

The landing gear of the massive C-5 Galaxy military transport airplane is a feat of heavy-load engineering. The plane's paint alone weighs 2,600 lb. Fully loaded, its maximum weight tops 380 tons, and it can land that load in just 4,900 ft of runway, even on substandard surfaces.

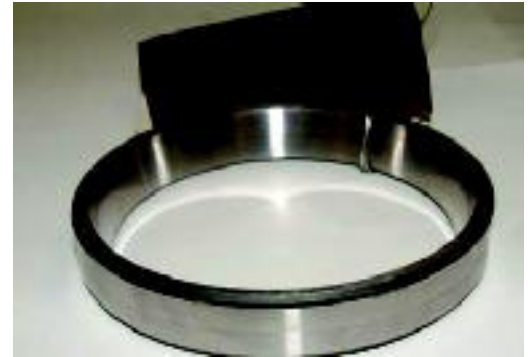
E-2C bearing cone ring (top) lubricated with MIL-PRF-81322 grease after a 300-hr saltwater bath and subsequent cleaning shows extensive corrosion and pitting. The part was deemed unserviceable by the Navy. In contrast, the E-2C bearing cone ring (bottom) lubricated with MIL-PRF-32014 grease after a 300-hr saltwater bath looked like a brand new part.

In the saltwater immersion test E-2C bearing cones were coated with the test greases and suspended in a seawater tank for 300 hr. Additionally a small pump circulated the seawater to better expose the cones.

An inspection of test parts after the 300-hr immersion revealed the bearing cone coated with the original MIL-PRF 81322 grease had obvious oxidative discoloration. After cleaning it showed deep corrosion. Corrosion pits in the outer rim were 0.020 to 0.040-in. deep. Damage was so bad the part was no longer serviceable.

The MIL-PRF 32014 (Rheolube 374A) greased cone also emerged from the same saltwater bath with discoloration. But after cleaning it had no corrosion pits and was still serviceable. The discoloration came from the MIL-PRF 81322 sample's residue that settled on the cone lubricated with MIL-PRF 32014. And thus MIL-PRF 32014 did not oxidize. Engineers at the Naval Aviation (Navair) Depot in San Diego, where testing took place, reported the bearing cone lubricated with MIL-PRF 32014 looked like a brand new part.

Navair also tested a bearing cone that serves as a control piece, submerging it in saltwater for 300 hr with no grease at all. It showed less damage from corrosion than the cone lubricated with MIL-PRF-81322. While there was obvious surface corrosion, there was no deep pitting as observed on the MILPRF-81322 test part. When the control piece came out of the saltwater bath it had a gray surface. Materials analysis found the coating to be a calcium formation, which potentially limited the corrosion on the control bearing. Researchers speculate that the clay thickener in the MIL-PRF-81322 grease, which can be hydroscopic, apparently locks in water, forming the deep corrosion pits on the MILPRF 81322-test part.

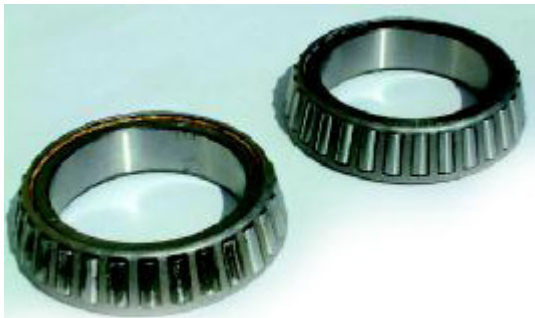
E-2C wheel assembly bearings after the wash test. The bearing lubricated with MIL-PRF-81322 grease (left) shows corrosion on all the rollers. The bearing lubricated with MIL-PRF 32014 grease (right) is in like-new condition with no visible corrosion

The wheel assemblies stood for 10 days before being torn down and inspected. Technicians reported that both wheel cavities contained large amounts of water, but the water in the MIL-PRF-32014-lubricated wheel was milky white. This indicates some degree of grease washed out of the assembly in the water. In contrast, the technicians noted that water from the MIL-PRF-81322-lubricated wheel remained clear, suggesting less washout.

The wheel-bearing cup assembled with MIL-PRF-81322 showed extensive corrosion after the 10-day test. The corresponding bearing roller also had broad corrosion. While less MIL-PRF-81322 grease washed out of the bearing, it reportedly absorbed water and changed color. As seen with the saltwater bath test, the

The teardown inspection on the wheel assembly lubricated with MIL-PRF-32014 showed the high pressure had washed out more grease. But there was less corrosion. After the 10-day test the bearing cup assembled with MIL-PRF-32014 was in excellent condition and still serviceable. The roller bearings had little to no corrosion and were also considered serviceable. Despite the washout of the grease during the test, the remaining film of grease was still able to provide good corrosion resistance.

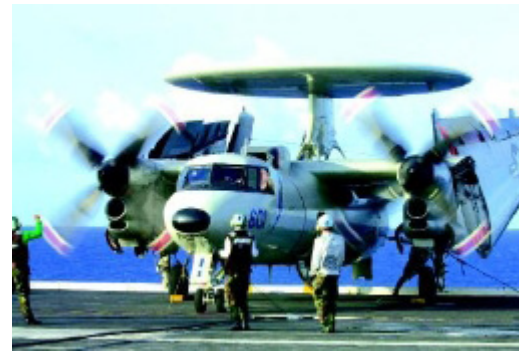
A high-pressure wash test was designed to flood bearing seals to test for corrosion resistance in the test greases. Wheel assemblies were exposed to a far more aggressive wash than what is considered standard procedure.

Other Navair tests subjected two new wheelbearing assemblies to high-pressure spray washes. The wheels

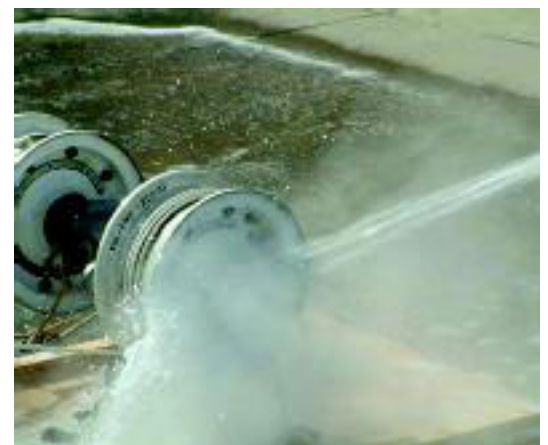
A high-pressure wash test was designed to flood bearing seals to test for corrosion resistance in the test greases. Wheel assemblies were exposed to a far more aggressive wash than what is considered standard procedure.

Technicians reported that the wheel lubricated with MIL-PRF-81322 had seized on to the axle, while the MIL-PRF-32014-lubricated wheel rotated freely. The caster barrel on which the wheels were mounted showed significant rusting after the 10-day trial, indicating how unlubricated parts may have fared in this same environment.

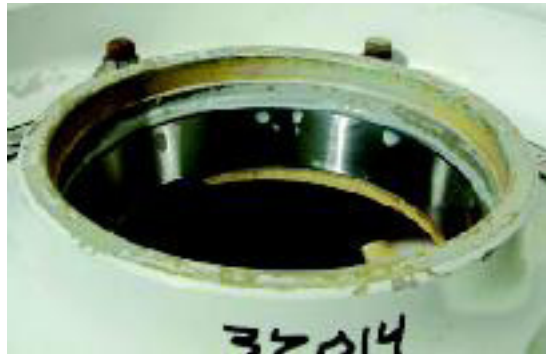
Bearing cup assembled with MIL-PRF-81322 grease (top) showed extensive corrosion after the 10-day wash test and actually seized on the axle, while the bearing cup assembled with MIL-PRF-32014 grease (bottom) is free of corrosion and still serviceable after the 10-day wash test. It is as clean and smooth as a new part

tendency for the MIL-PRF-81322 grease to absorb water may have compounded corrosive damage, rather than prevent it.
